Saline River Dam

Common Misconceptions

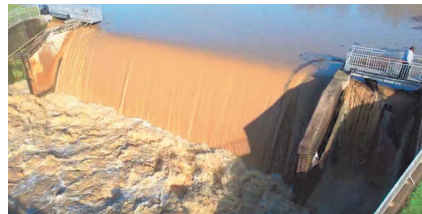
The Saline River Dam was not built for flood control, as such, it does little in the way of flood attenuation. Preliminary hydraulic modeling completed as part of this study indicate that removal of the dam would have negligible impacts to the water surface elevation downstream, even following runoff events. Although removal of the dam does eliminate the impoundments, storage is gained by shaping floodplain shelf as part of river restoration efforts.

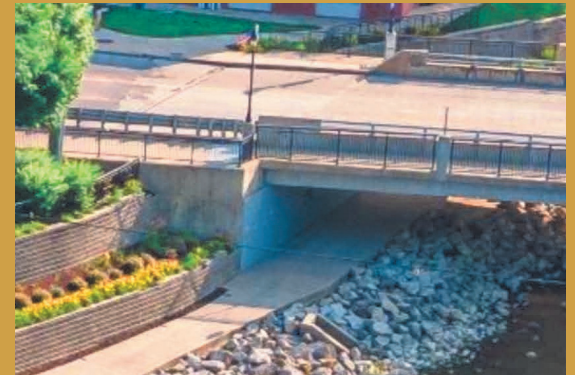
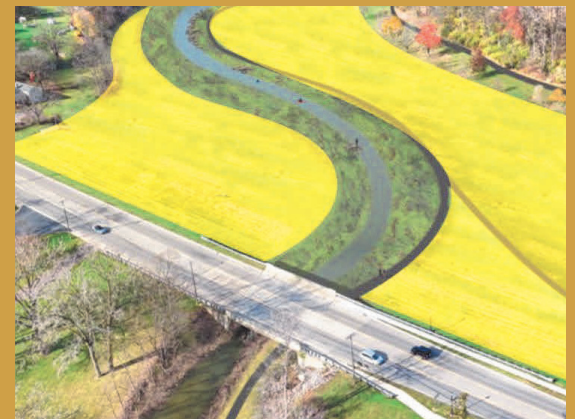
Potential safe pedestrian crossing under US-12 connecting Mill Pond and Curtiss Parks. The above image is from Dundee Michigan,, the below image is a rendering of Mill Pond Park if the dam was removed.

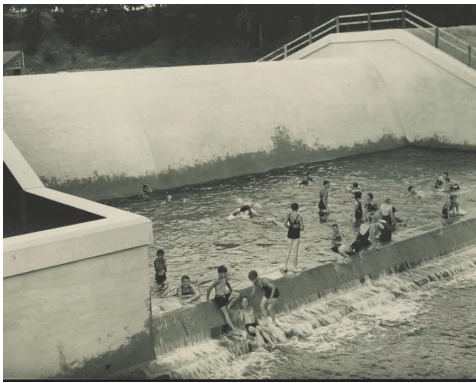
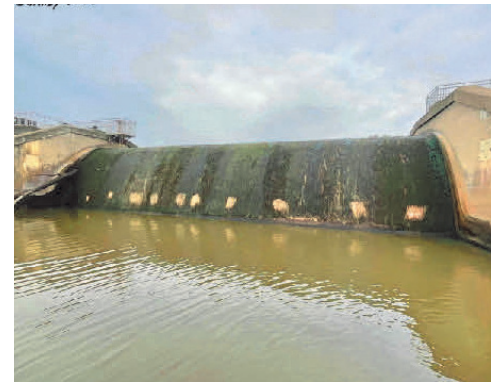
Spillway

The dam spillway was constructed in 1935. A picture of the new spillway from the year it was constructed is shown on the left. The picture on the right was taken in 2021 as part of the recent structural inspection.

As outlined in the 2021 structural report, the concrete is deteriorating and needs repairs.

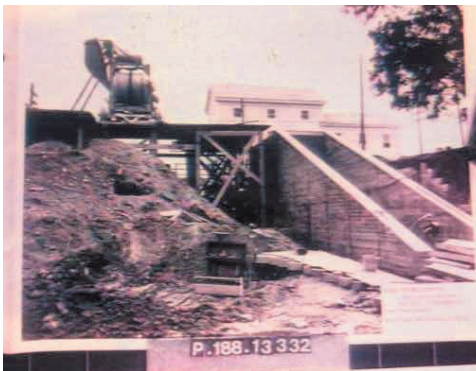
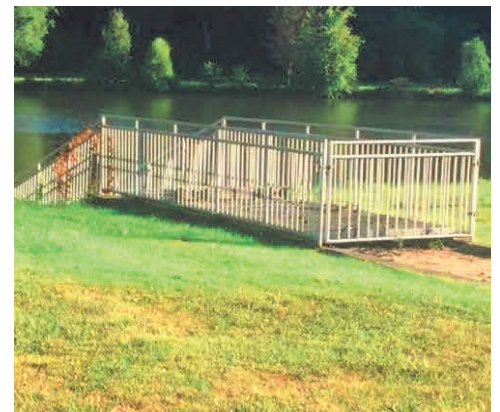
Mill Race

The mill race was constructed in 1935 and historically routed water under Michigan Avenue to turn a turbine at the mill to produce electricity.

A picture of the mill race while under its initial construction is shown on the left. On the right is a photo of the existing safety railing at the top of the mill race on the south west portion of Mill Pond Park.

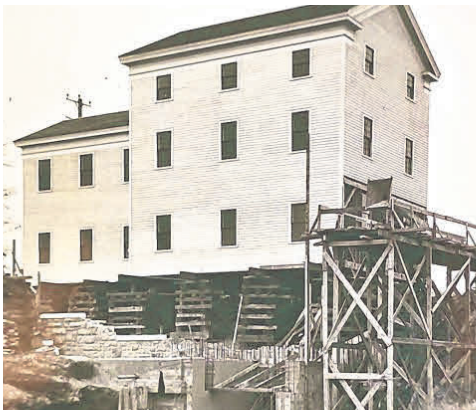
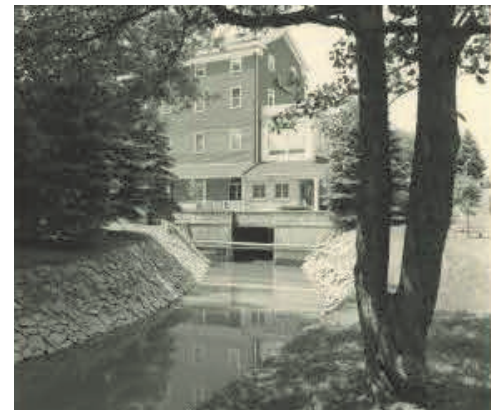
Mill & Tail Race

The photo on the right shows the tail race downstream of the historic turbine and mill. The photo on the left shows construction of the turbine over the mill race at Wellers in the 1930s.

Dam removal could result in removal of the tail race also. The City is looking at options to keep the tail race functioning should the dam be removed. The tail race currently feeds a stream of water through the Wellers property.
